CORROSION 2007

PAPER NO. 07450

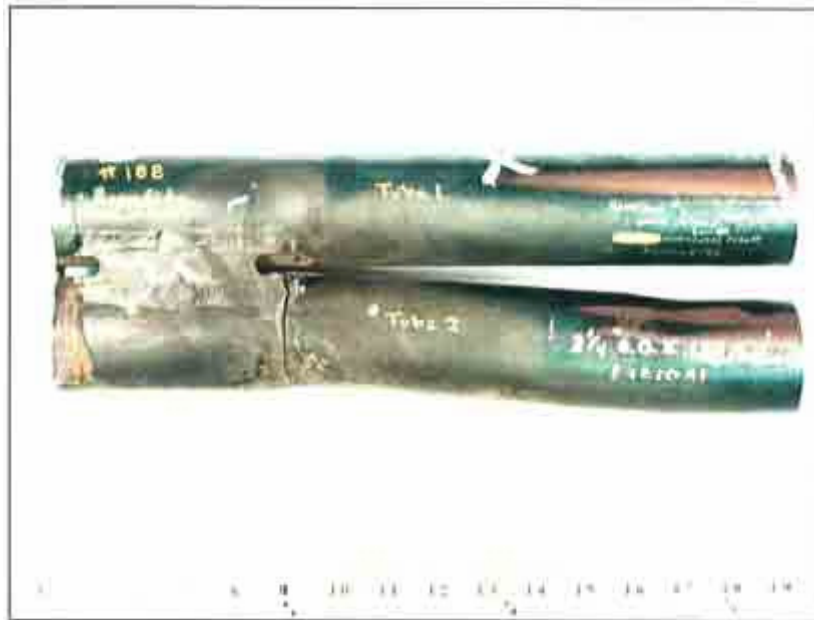
FIGURE 1 - Photograph showing the as received reheat tube assembly.

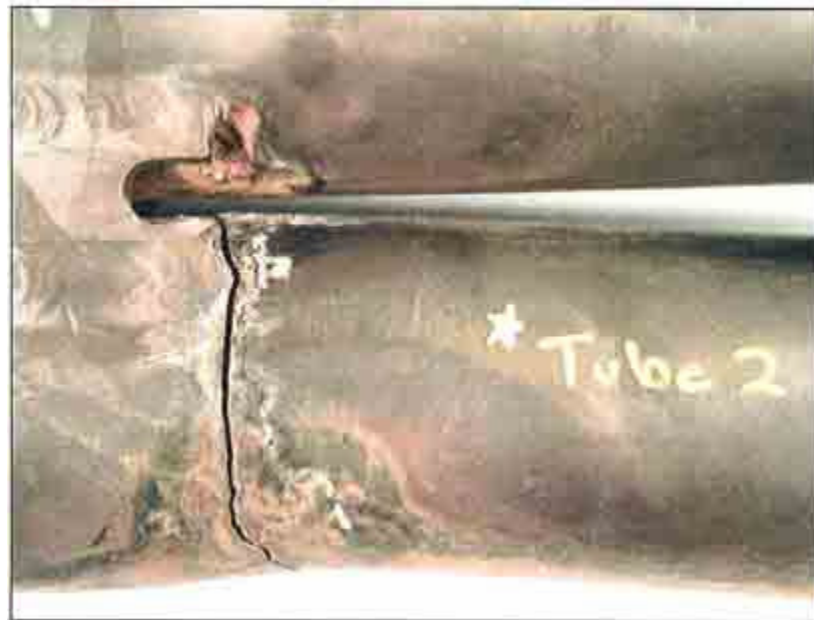
FIGURE 2 - Photograph showing the circumferential crack in tube no. 2.

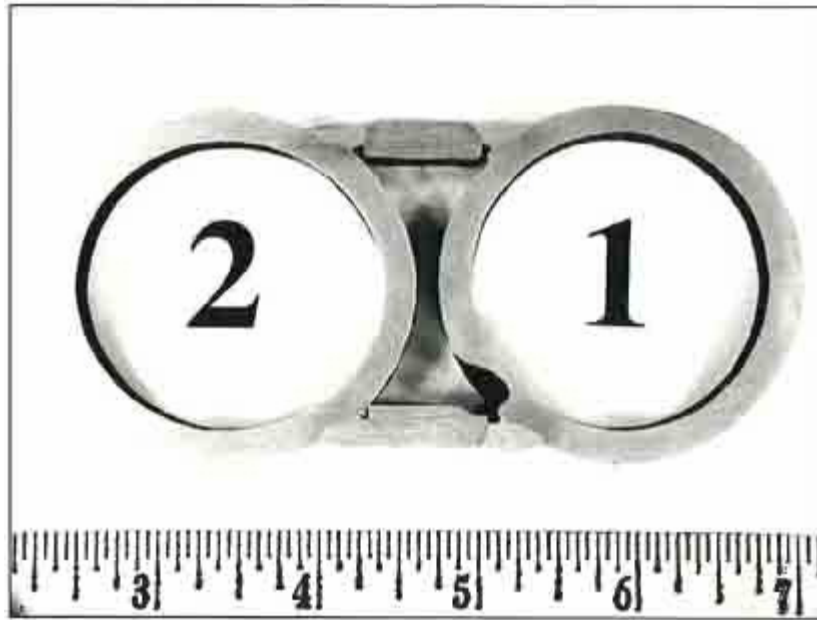
FIGURE 3 - Photograph showing the geometry of the welded assembly.

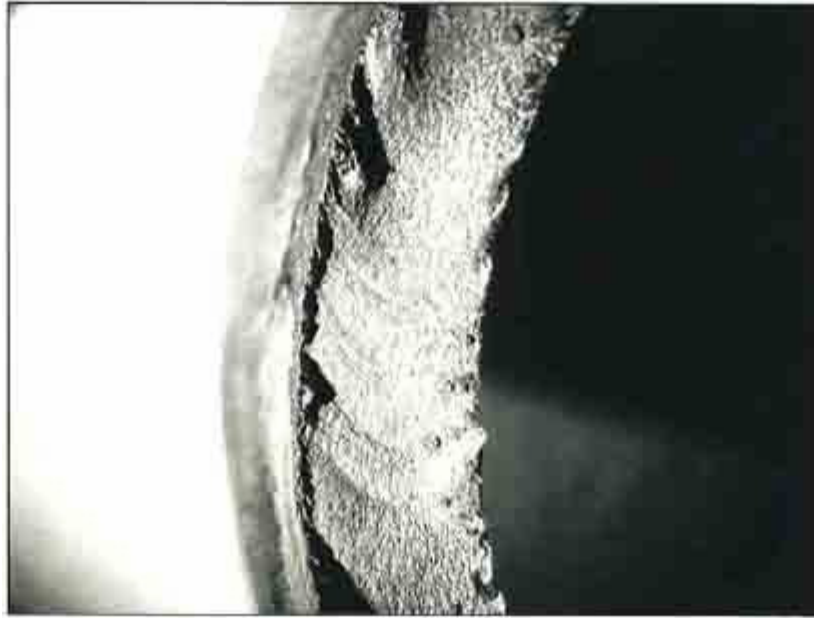
FIGURE 4 - Photograph showing parallel fatigue crack arrest marks on the fracture surface.

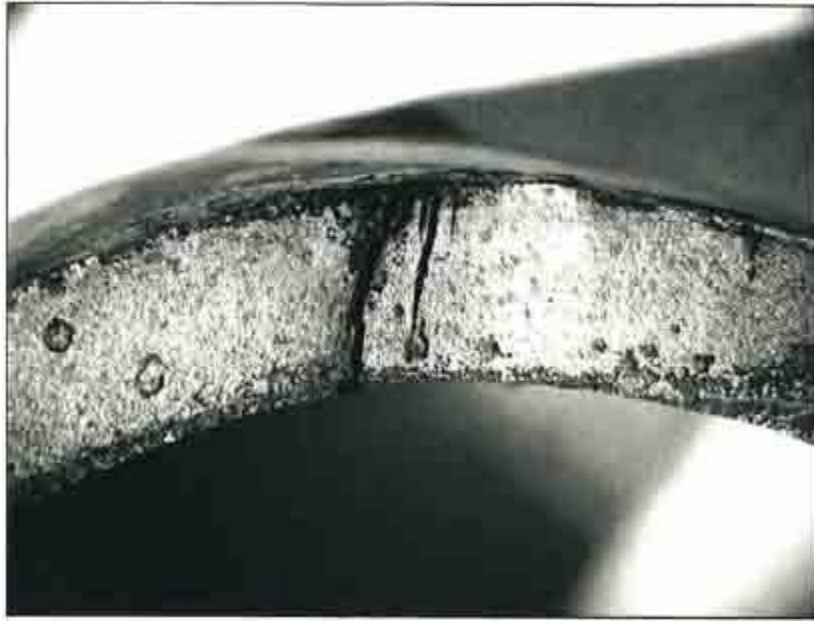
FIGURE 5 - Photograph showing one of the mating fracture initiation sites.

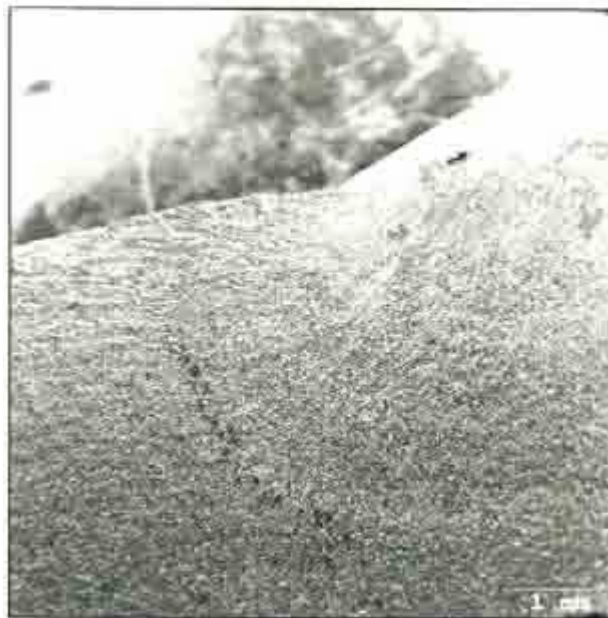
FIGURE 6 - Scanning electron micrograph at 14x showing fatigue crack arrest marks adjacent to the fracture initiation location.

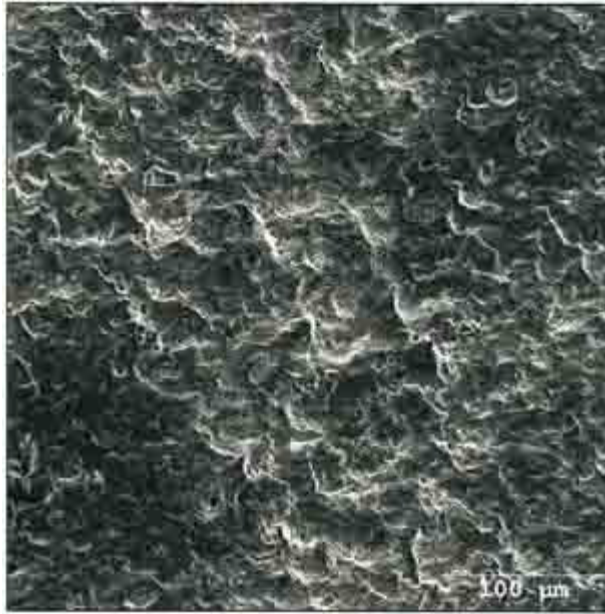
FIGURE 7 - Scanning electron micrograph at 245x showing a series of fatigue crack arrest marks.

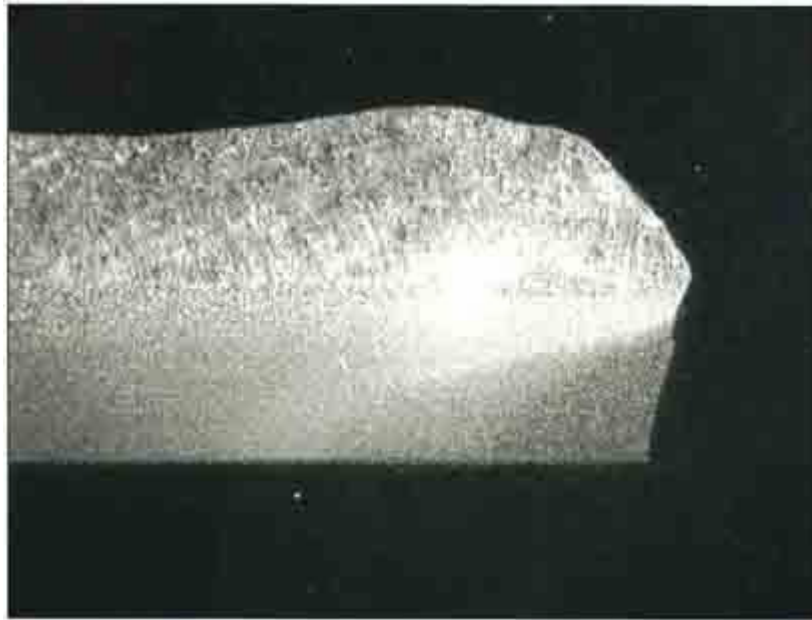
FIGURE 8 - Photograph at 8x showing the fracture initiation site at the weld toe location. 2% nital.

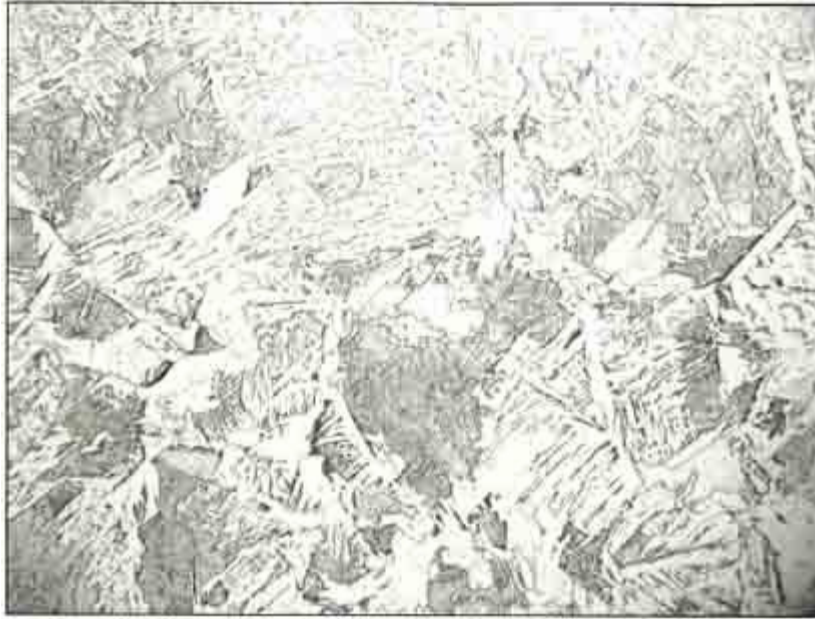
FIGURE 9 - Photograph at 400x showing the microstructure of the heat affected zone (HAZ); 2% nital.

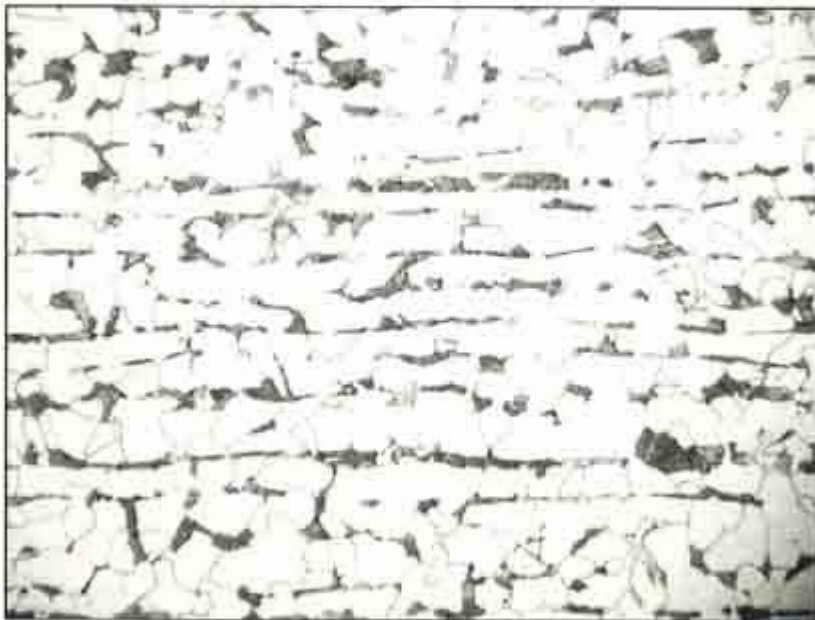
FIGURE 10 - Photograph at 400x showing the base metal microstructure; 2% nital.

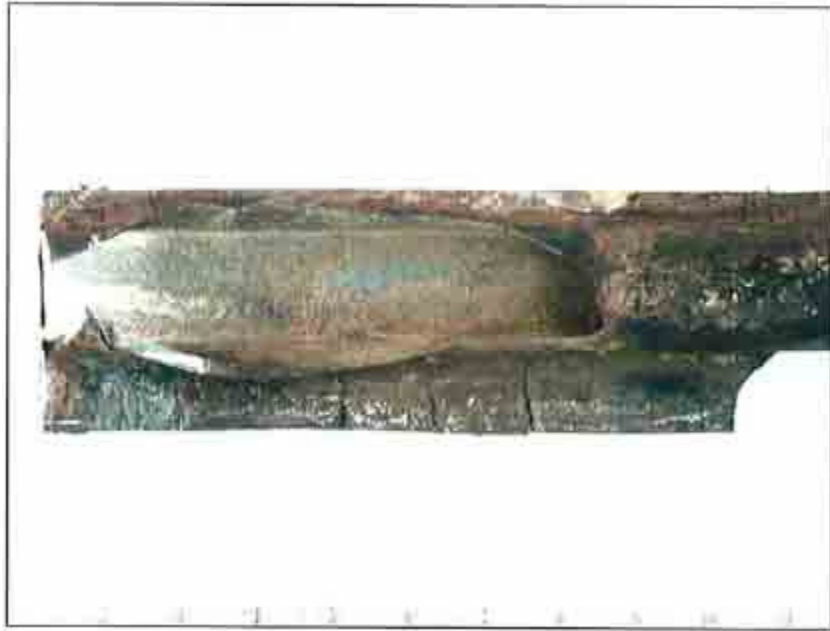
FIGURE 11 - Photograph at 1.4x showing the window failure in the waterwall tube.

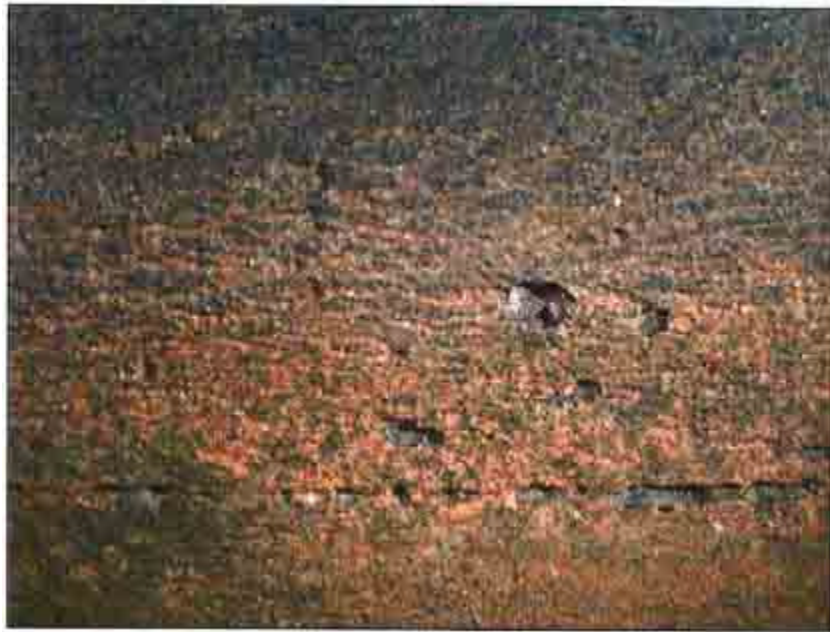
FIGURE 12 - Photograph at 8x showing shallow corrosion pitting of the ID tube surface.

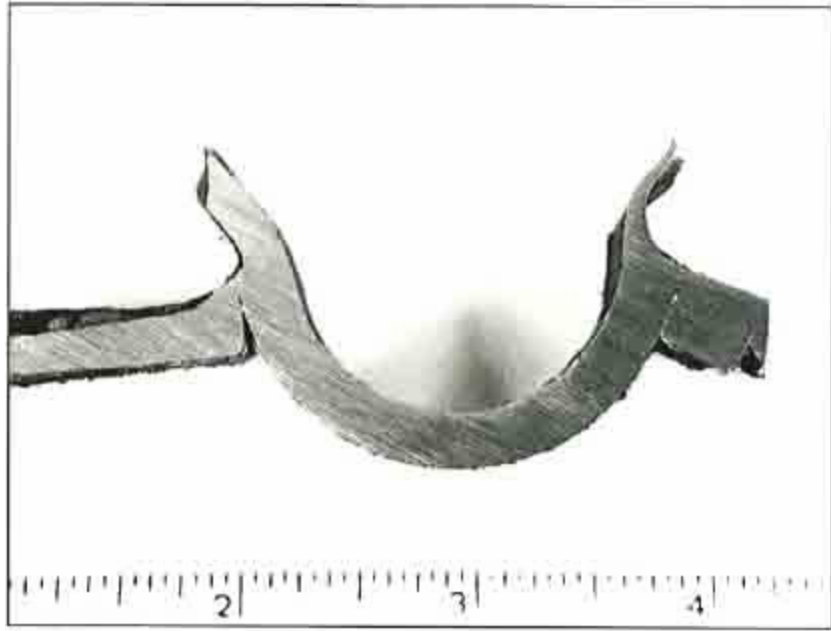
FIGURE 13 - Photograph at 2x showing the tube wall thickness profile at the location of failure.

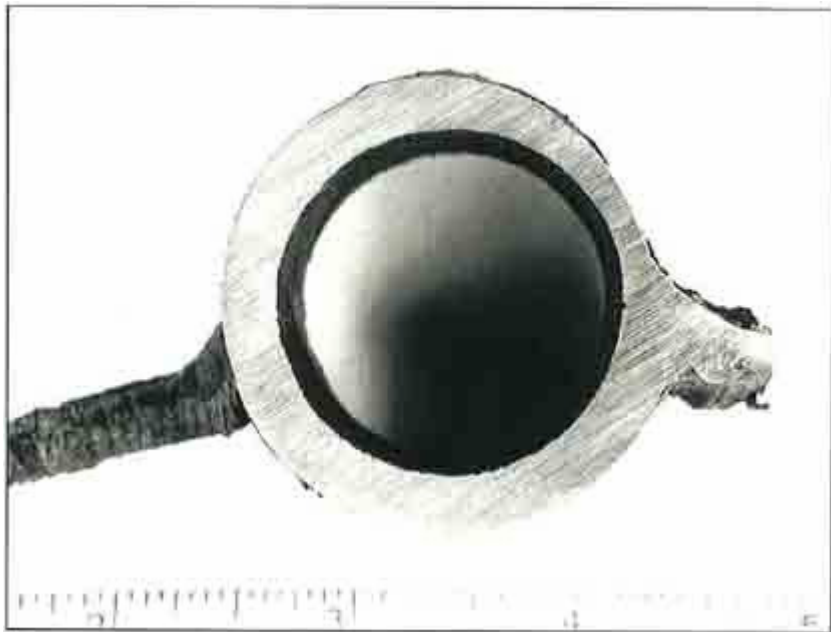
FIGURE 14 - Photograph at 2x showing the tube wall thickness profile away from the location of failure.

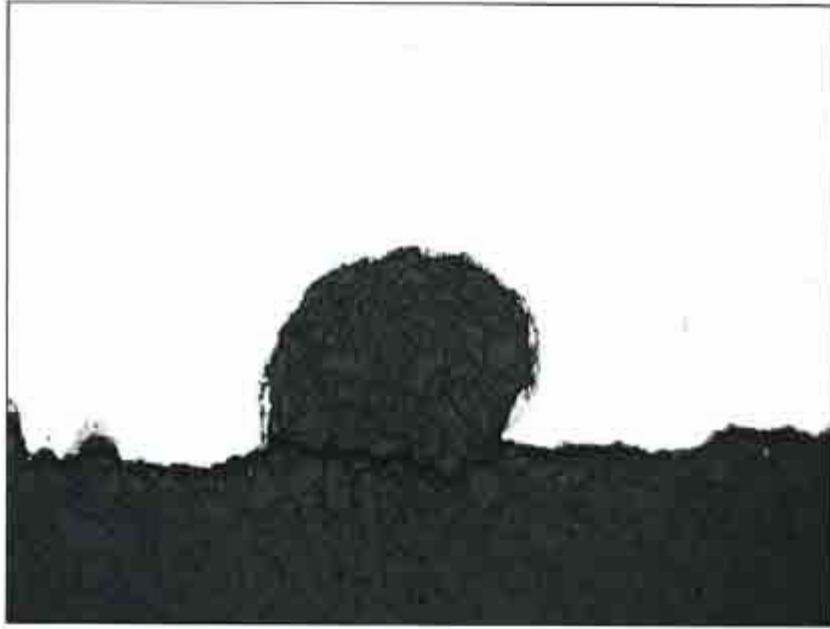
FIGURE 15 - Photograph at 100x showing corrosion pitting at the ID surface of the tube; as polished.

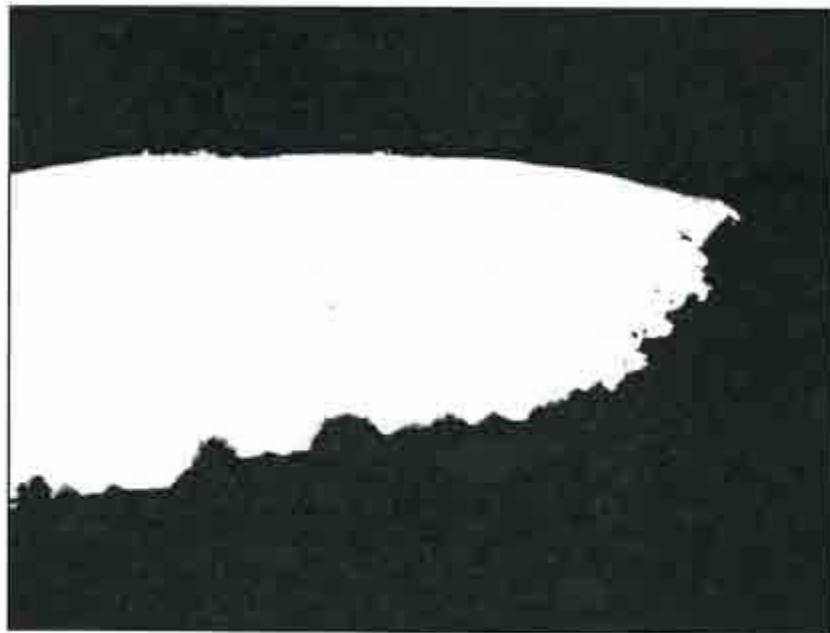
FIGURE 16 - Photograph at 50x showing the thinner fracture surface profile; as polished.

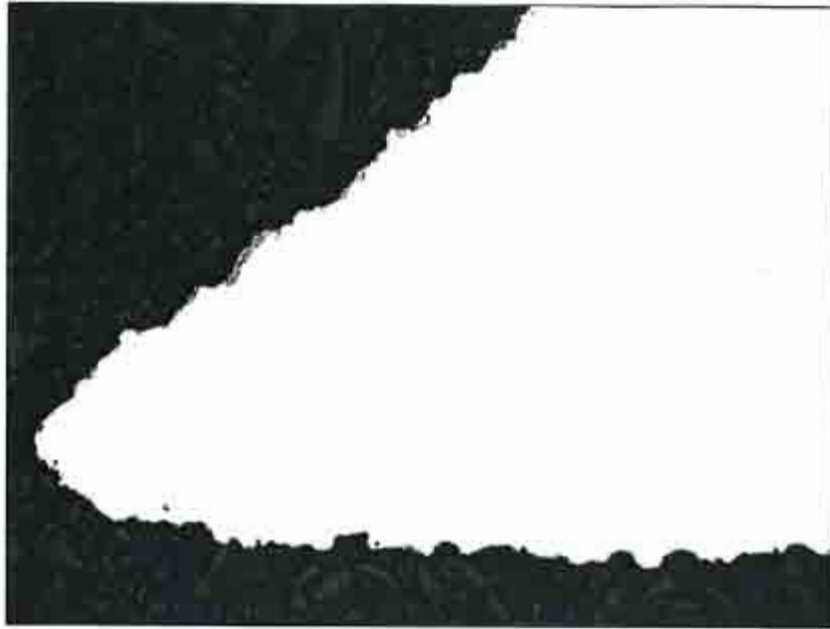
FIGURE 17 - Photograph at 50x showing the thicker fracture surface profile at the ID surface; as polished.

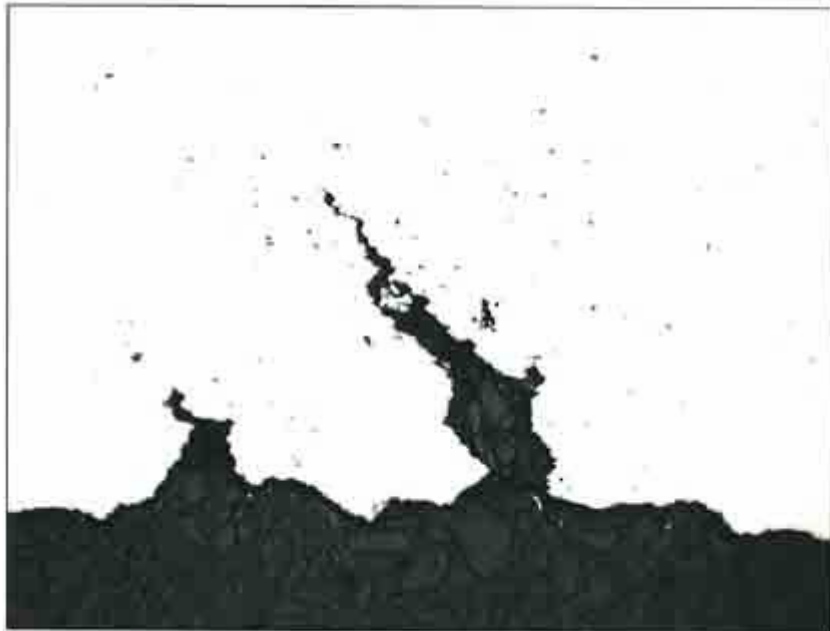
FIGURE 18 - Photograph at 100x showing secondary cracks initiating at the ID tube surface; as polished.

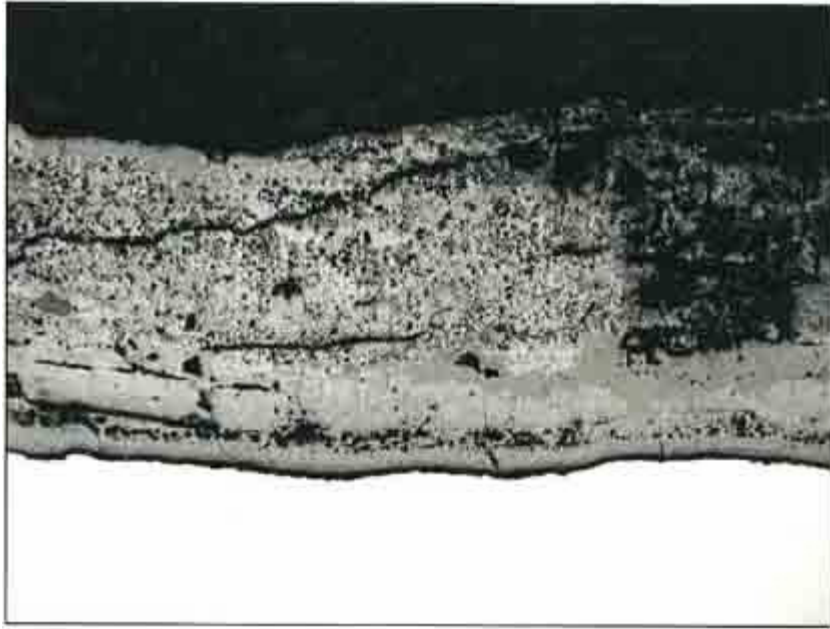
FIGURE 19 - Photograph at 50x showing the scale deposits on the OD tube surface; as polished.

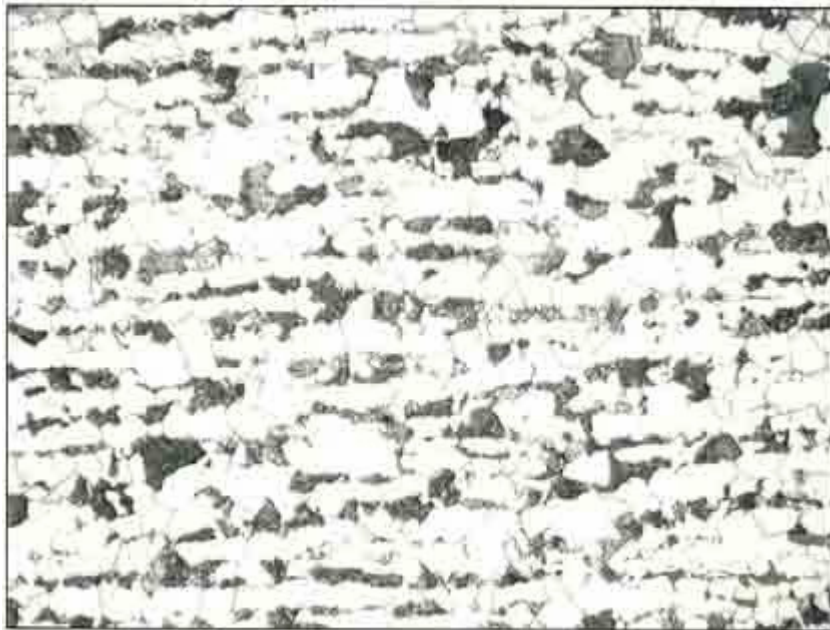
FIGURE 20 - Photograph at 400x showing the microstructure of the tube away from the failure; 2% nital.

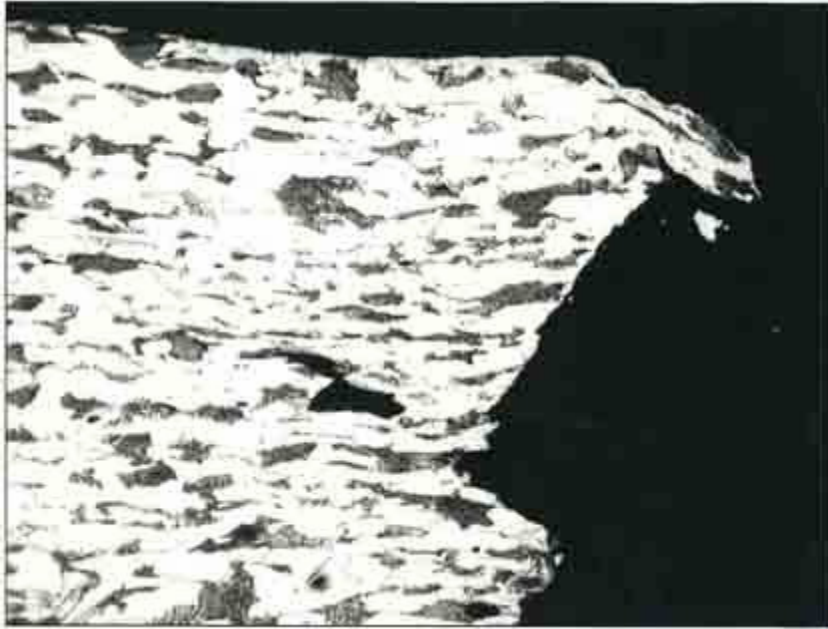
FIGURE 21 - Photograph at 400x showing the tube microstructure at the thinner fracture surface; 2% nital.

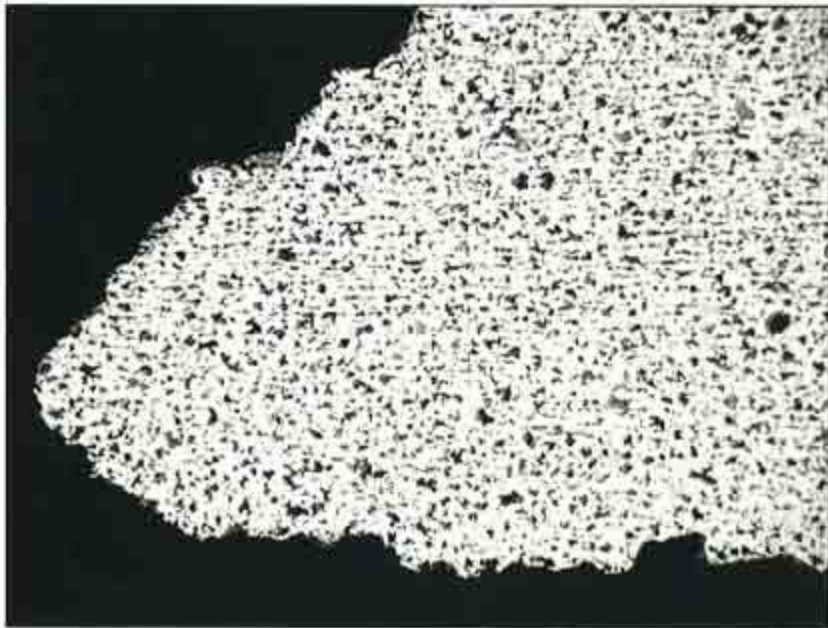
FIGURE 22 - Photograph at 100x showing the tube microstructure of the thicker fracture at the OD surface; 2% nital.

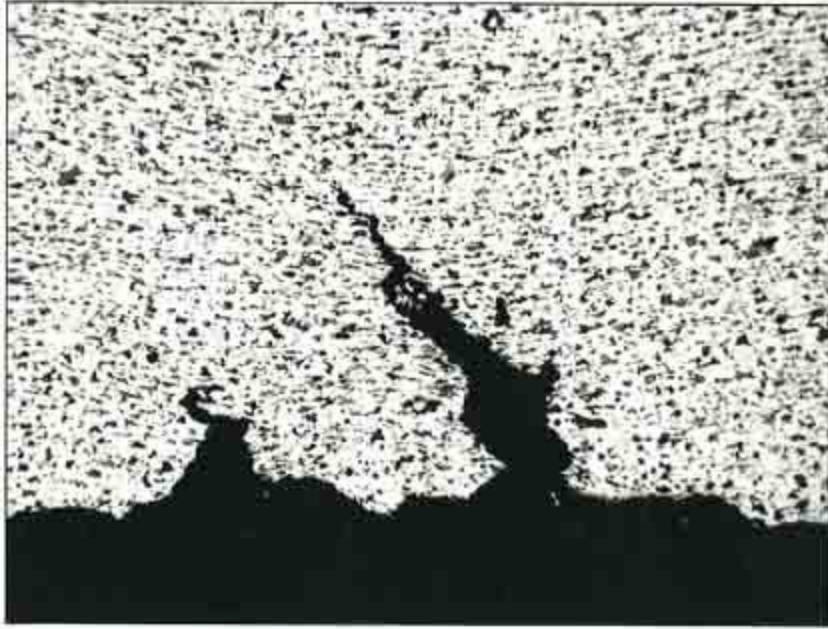
FIGURE 23 - Photograph at 100x showing the tube microstructure at the location of the secondary cracks; 2% nital.

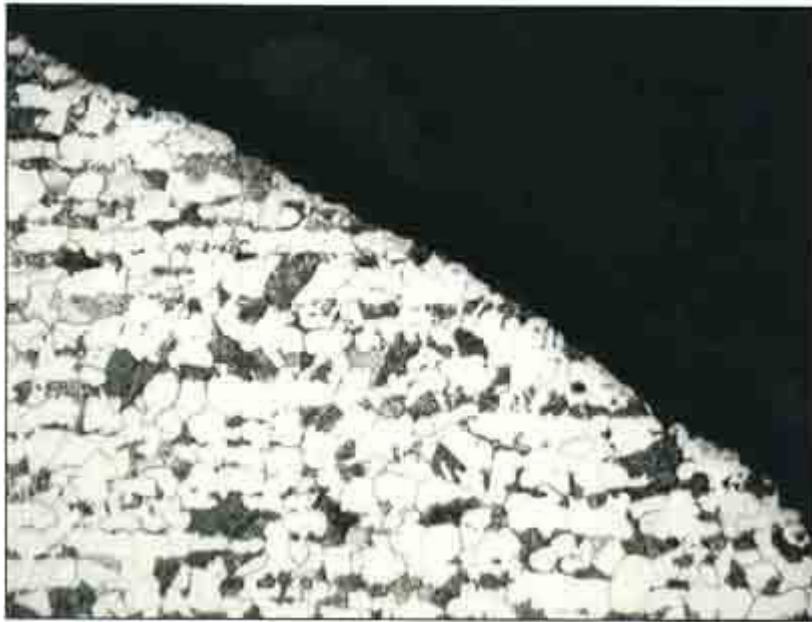
FIGURE 24 - Photograph at 400x showing the smooth eroded OD surface profile of the tube; 2% nital.

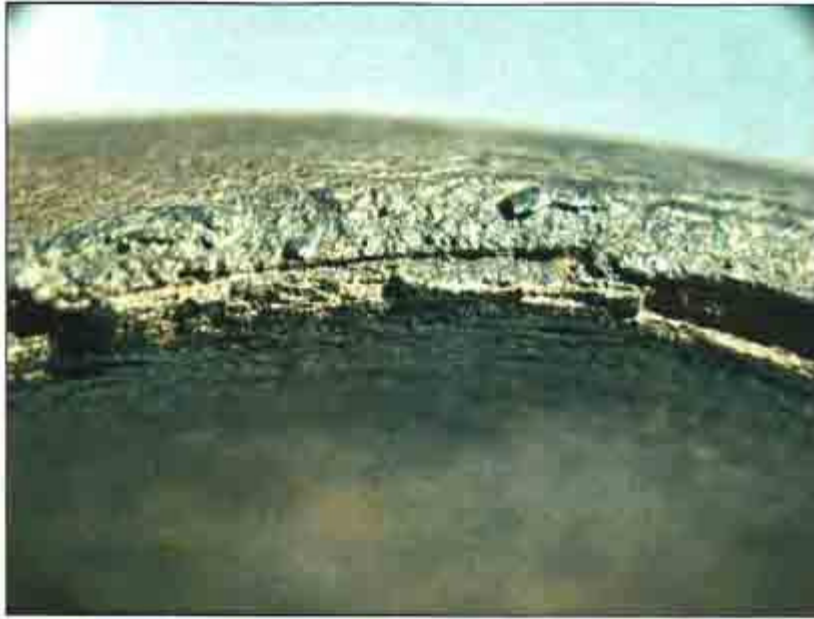
FIGURE 27 - Photograph at 8x showing the thinner walled fracture surface.

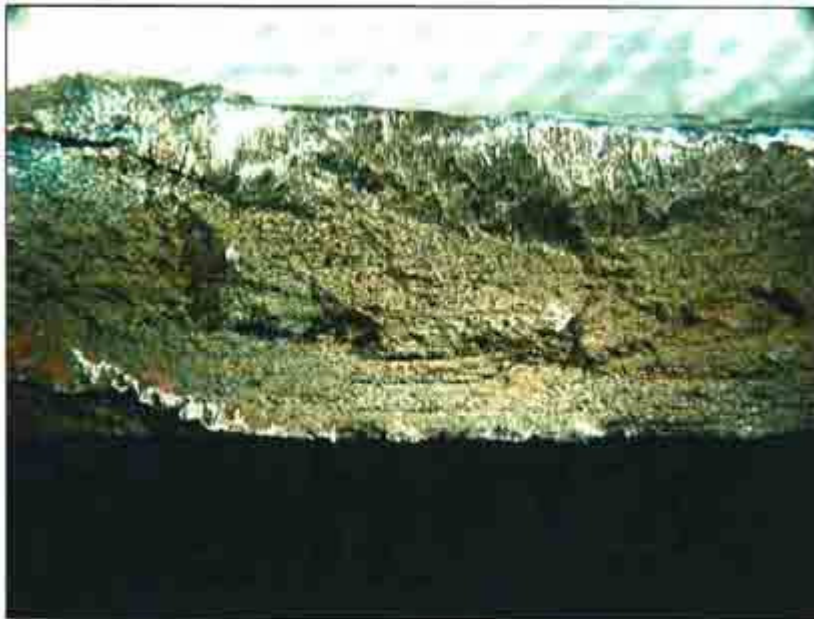
FIGURE 28 - Photograph at 8x showing the thicker walled fracture surface.

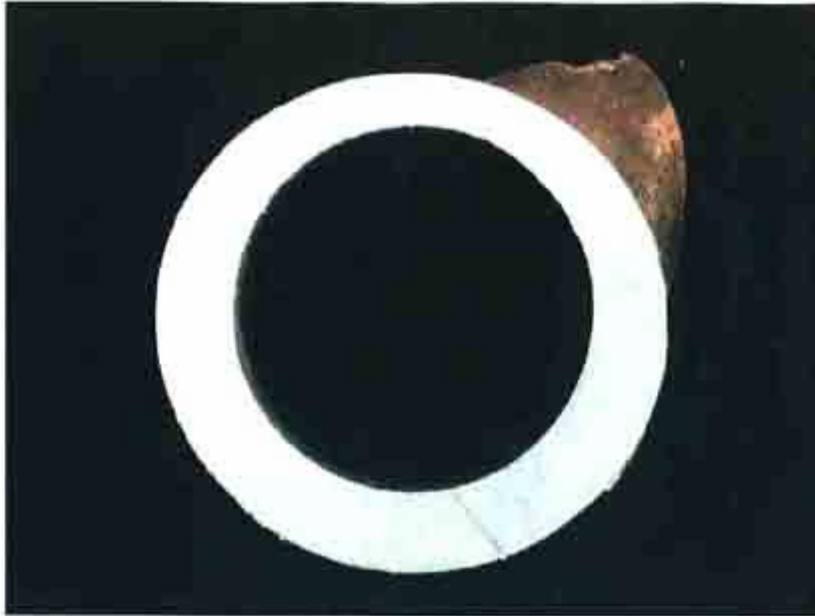
FIGURE 29 - Photograph showing the non uniform tube wall thickness.

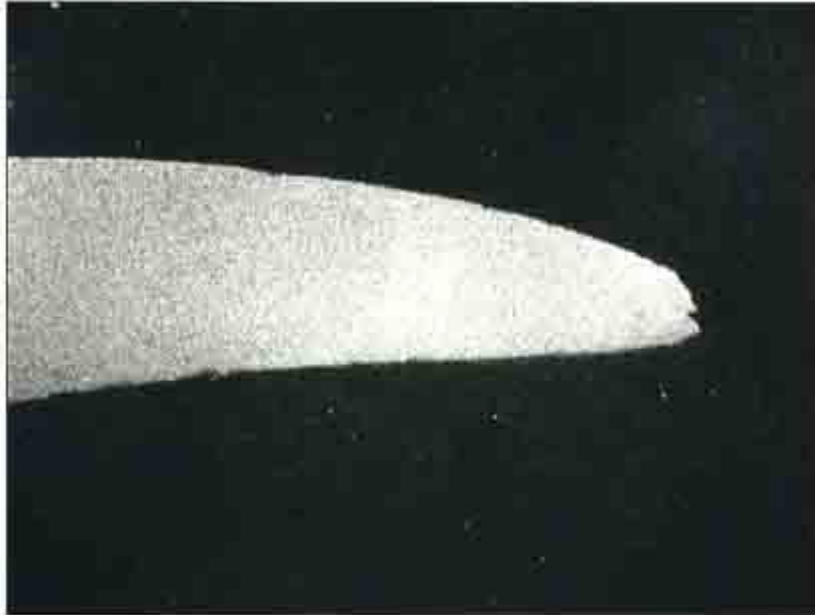
FIGURE 30 - Photograph at 8x showing the thin walled fracture surface profile; 2% nital.

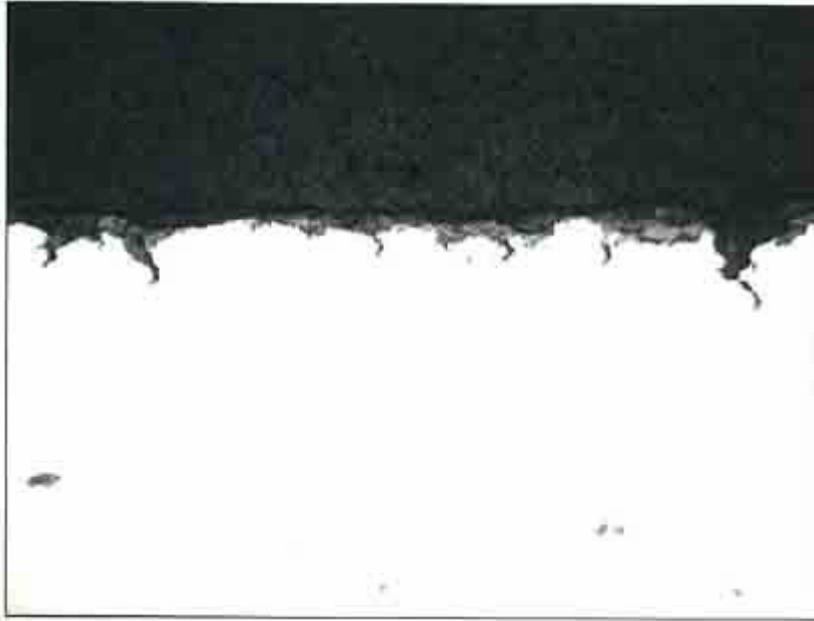
FIGURE 31 - Photograph at 400x showing secondary cracks near the fracture at the OD tube surface; as polished.

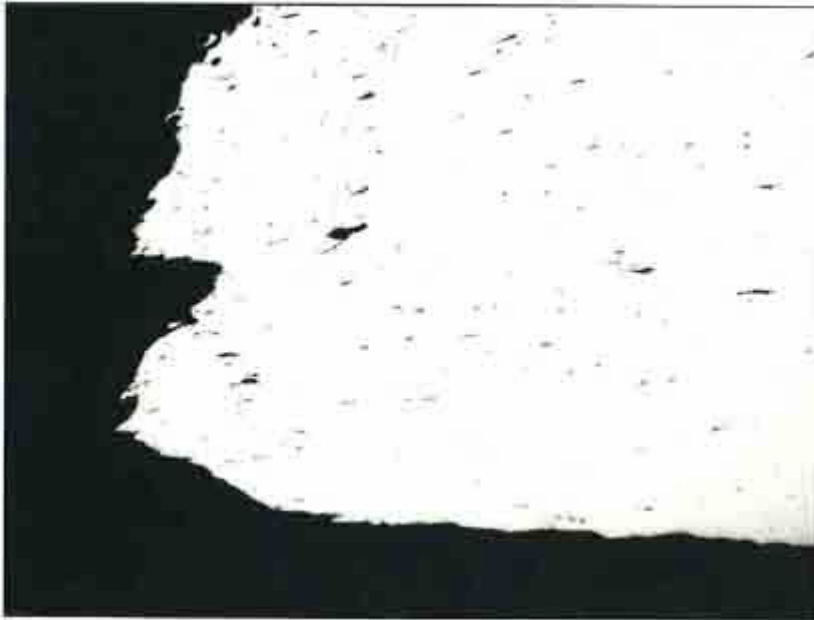
FIGURE 32 - Photograph at 50x showing the thin wall fracture profile at the ID surface; as polished.

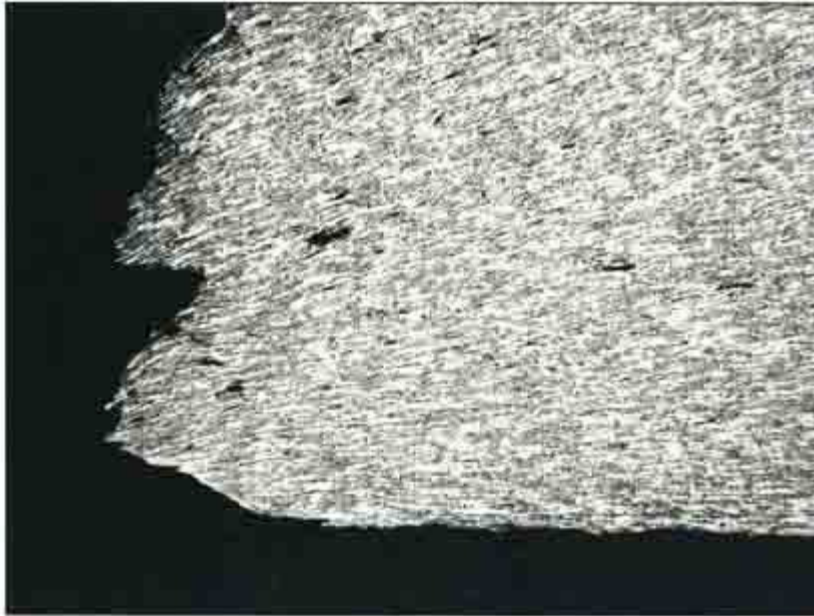
FIGURE 33 - Photograph at 50x showing the thin wall fracture profile at the ID surface; 2% nital.

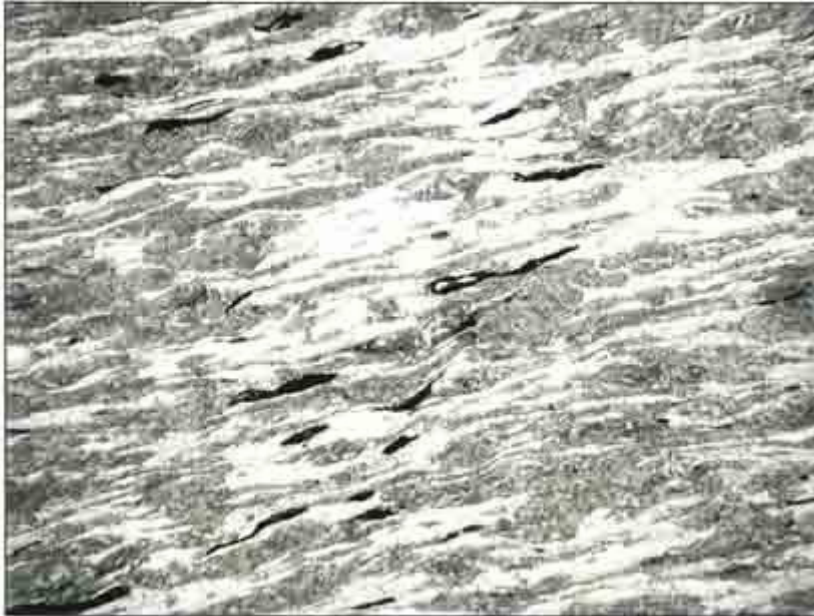
FIGURE 34 - Photograph at 400x showing the tube microstructure adjacent to the thin wall fracture; 2% nital.

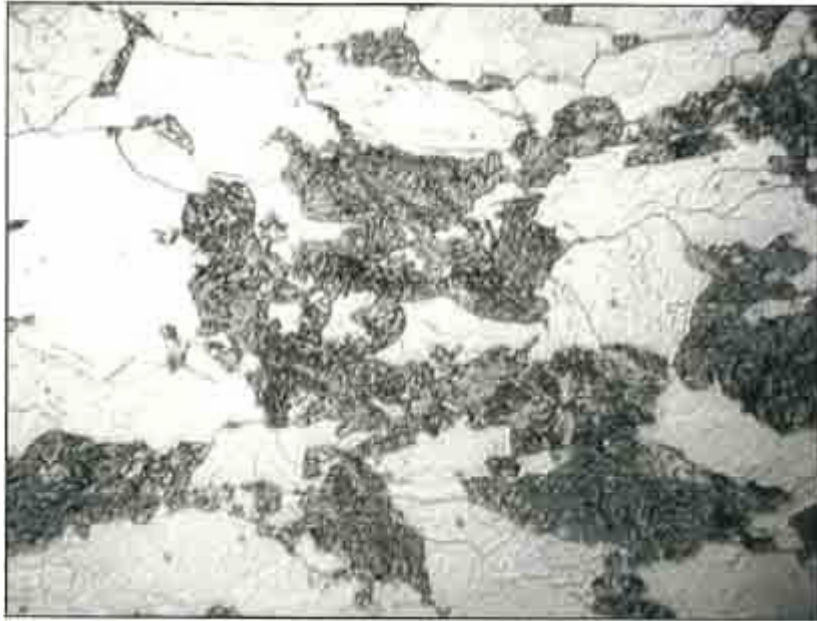
FIGURE 35 - Photograph at 1000x showing the tube microstructure away from the thin wall fracture; 2% nital.

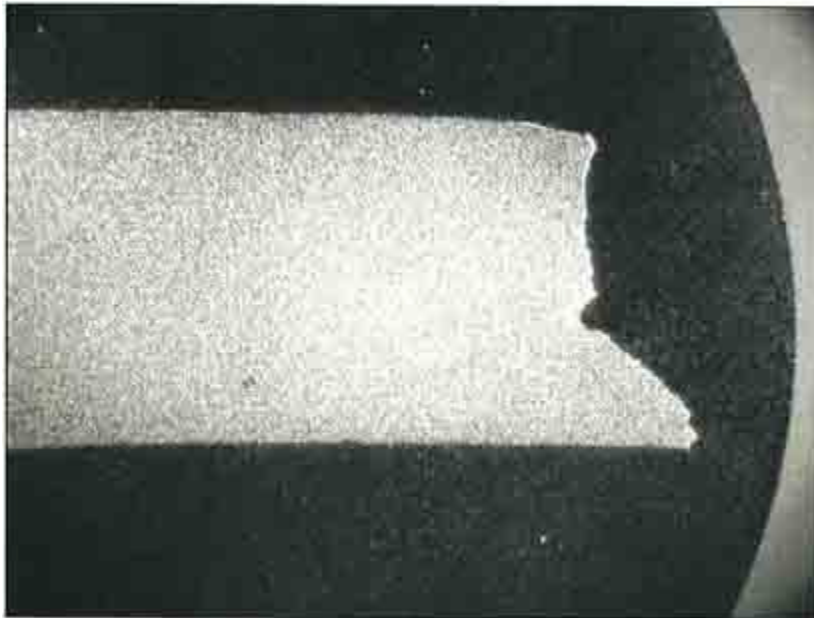
FIGURE 36 - Photograph at 8x showing the thick wall fracture surface profile; 2% nital.

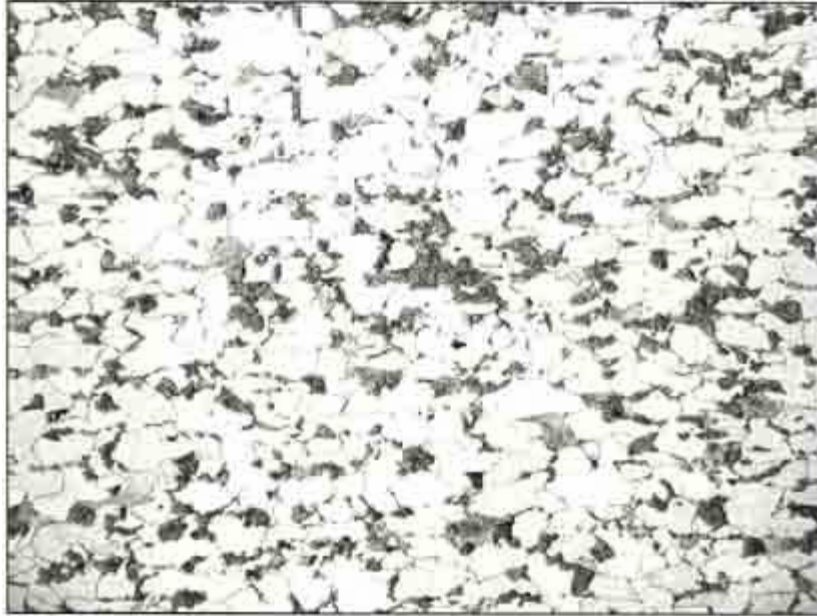
FIGURE 37 - Photograph at 200x showing the tube microstructure near the thick wall fracture; 2% nital.

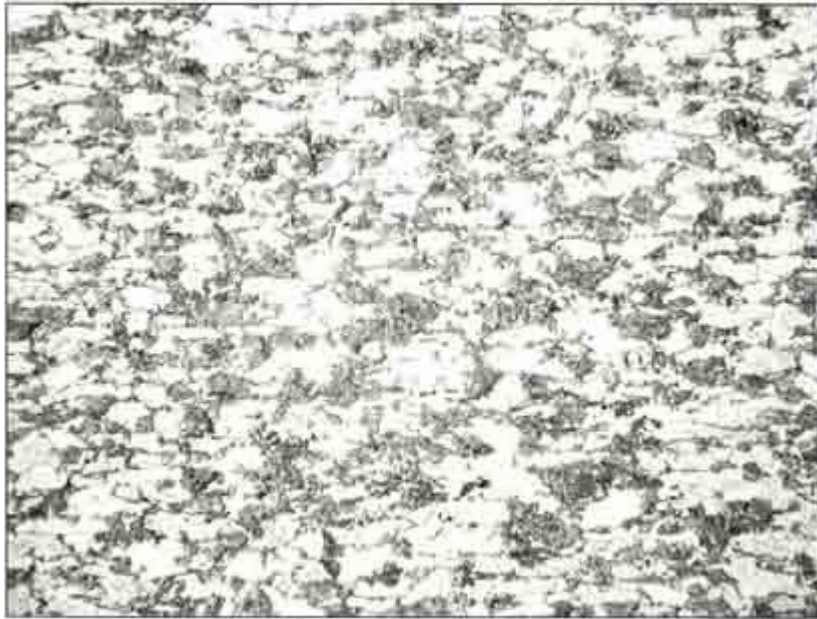
FIGURE 38 - Photograph at 200x showing the tube microstructure away from the fracture in the thinnest wall area; 2% nital.

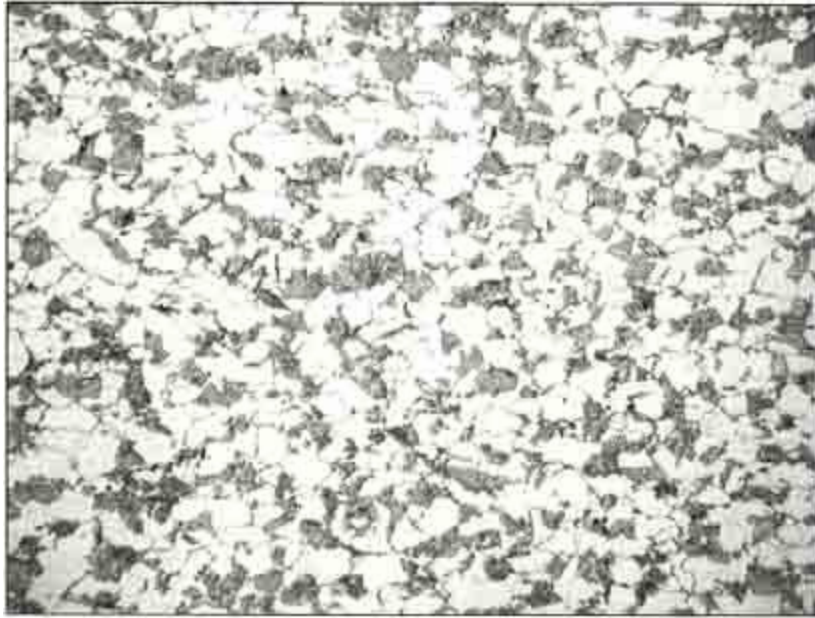
FIGURE 39 - Photograph at 200x showing the tube microstructure away from the fracture in the thickest wall area; 2% nital.

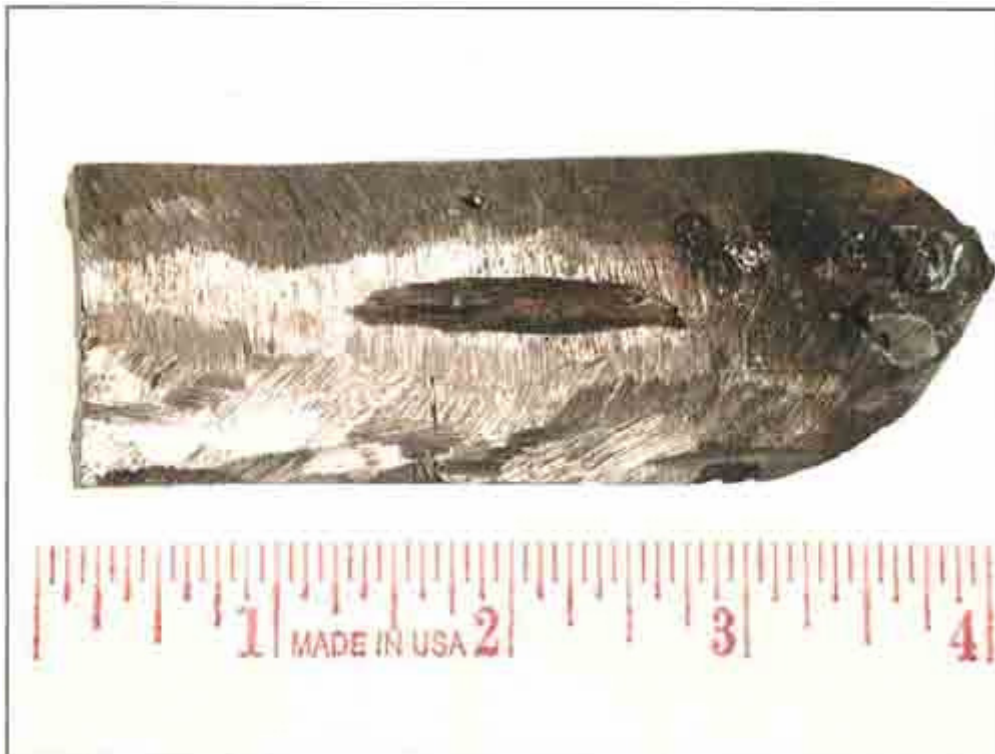
FIGURE 40 - Photograph showing the OD surface of the as received tube section.

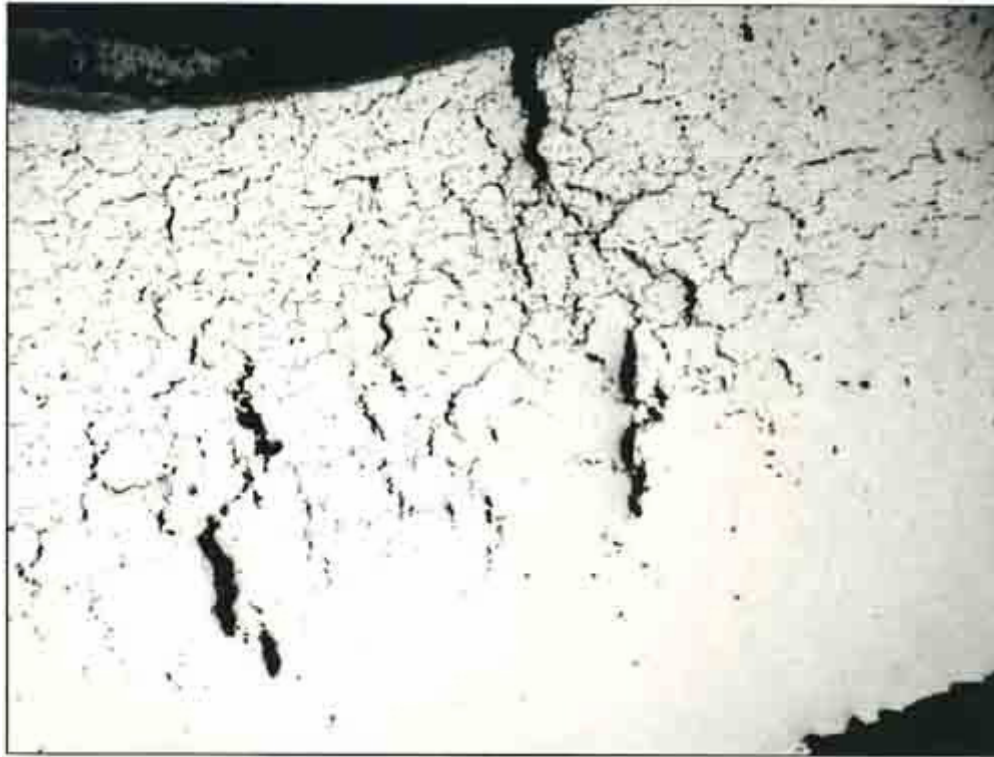
FIGURE 46 - Photograph at 50x showing cracking and hydrogen damage void formation; as polished.

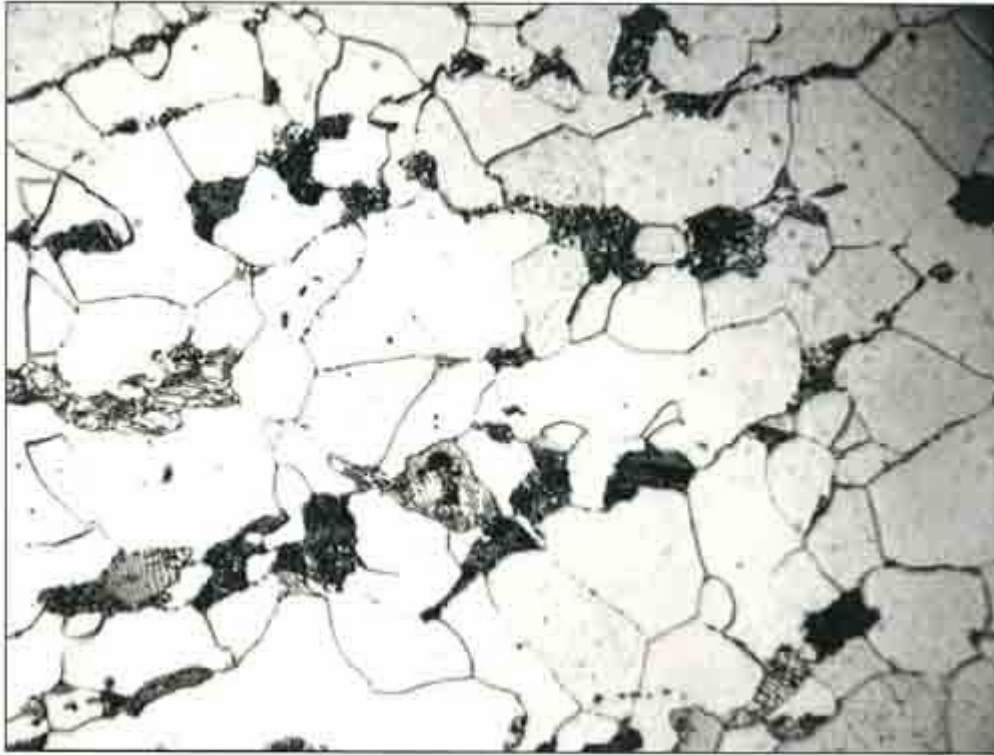
FIGURE 47 - Photograph at 1000x showing the microstructure of the tube; 2% nital.

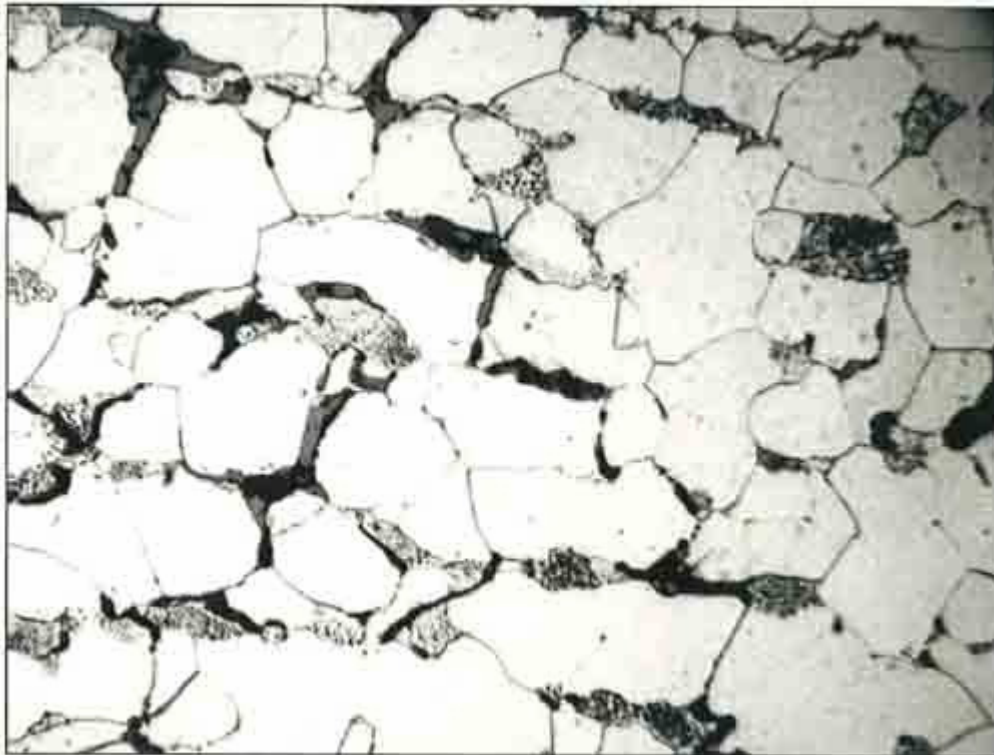
FIGURE 48 - Photograph at 1000x showing the microstructure of the tube in the hydrogen damaged area; 2% nital.
